***Technical Review — Crown Pillar Subsidence  
and Hydrologic Stability Assessment  
for the Proposed Eagle Mine  
(DRAFT)***

Prepared for:  
MFG, Inc  
Michigan Department of Environmental Quality

Prepared by:  
David Sainsbury, Ph.D.  
Itasca Consulting Group, Inc.

May 2006

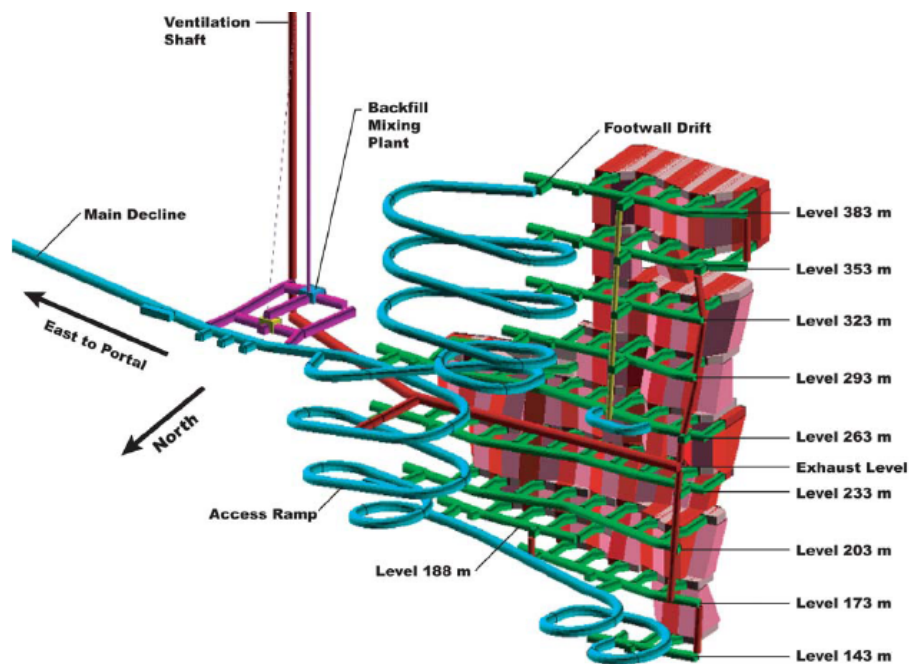
*Figure 1 Schematic of proposed Eagle Mine stoping geometry (Kennecott, 2006)*

The Eagle Project Mining Permit Application (Kennecott, 2006) describes the proposed mining plan as a transverse longhole method. Mining of the open stopes will use primary and secondary mining sequences with delayed placement of backfill. Mining will progress from mine level 143 m (~ 295 m below ground surface) upward to mine level 353 m (~ 85 m below ground surface). Mine level 383 m (~ 55 m below ground surface) will be mined selectively based upon future geotechnical analysis. The contact between the peridotite and the overlying glacial till is located at the 415 m level and results in a peridotite crown pillar thickness of either 57.5 m or 27.5 m, depending whether the 383 m level is extracted. Figure 1 illustrates a schematic of the proposed Eagle Mine stoping geometry.

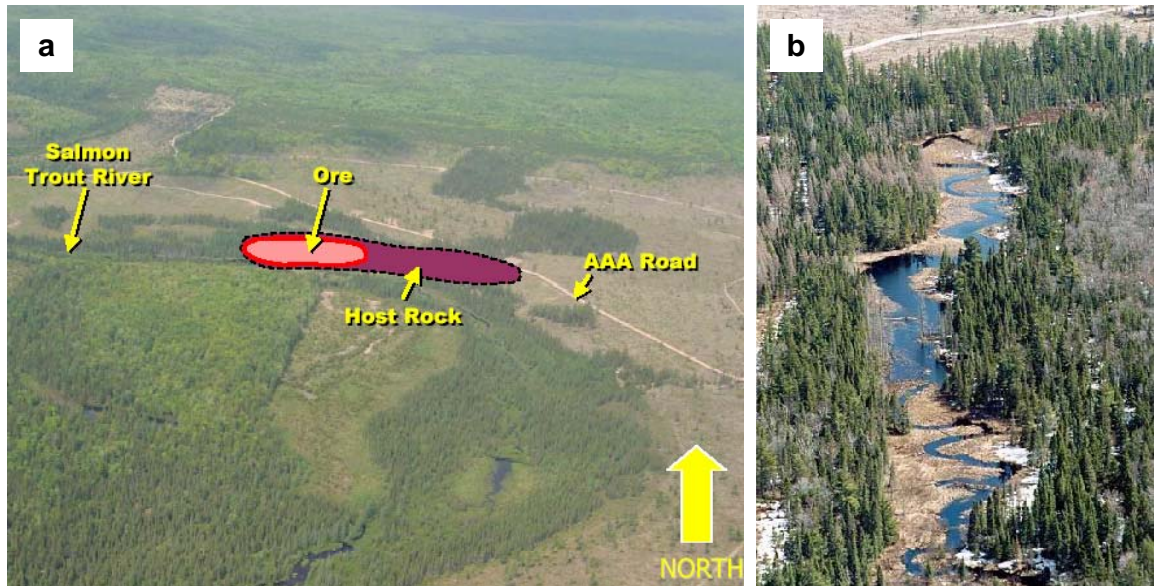
**Figure 2** a) Aerial view of the proposed underground mine; b) Salmon Trout River above orebody

The Salmon Trout River flows above the orebody, and the area is surrounded by wetlands, as illustrated in Figure 2a and Figure 2b.

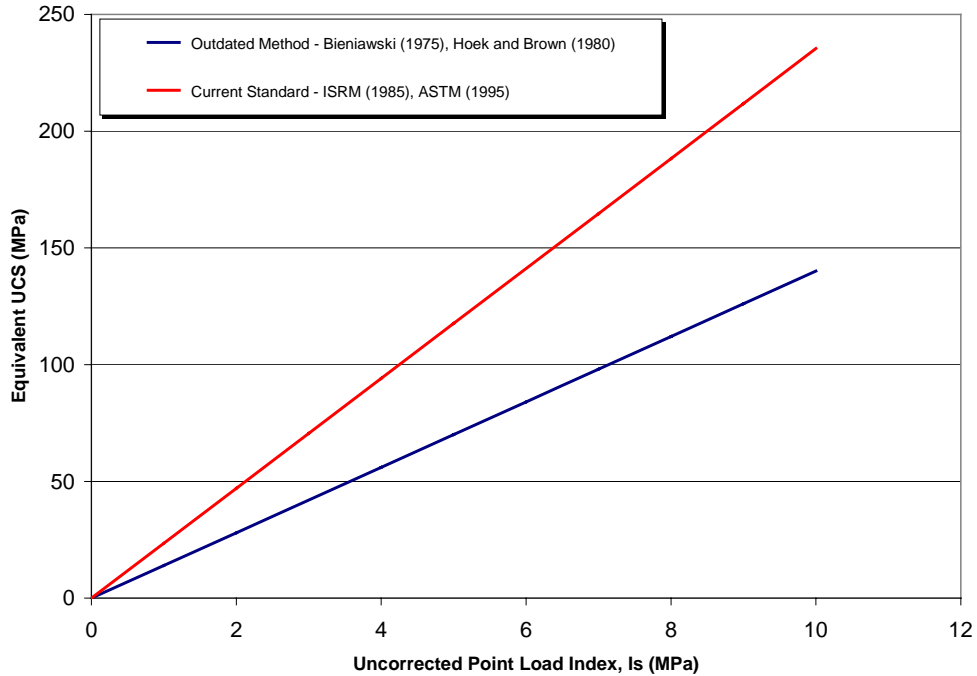
**Figure 3 Comparison between equivalent UCS obtained using outdated method and the current ISRM and ASTM methods assuming the default conversion factor of 24**

is not consistent with the current International Society of Rock Mechanics (ISRM) suggested method for determining point load strength (ISRM, 1985) or the ASTM standard test method for determining the point load strength index of rock (ASTM, 1995). The current standard methods apply a size correction factor and a UCS correlation factor to the uncorrected point load strength index. Figure 3 illustrates the significant difference that can be obtained when using the current standard point load determination method with the default conversion factor (24), compared to the outdated methods.

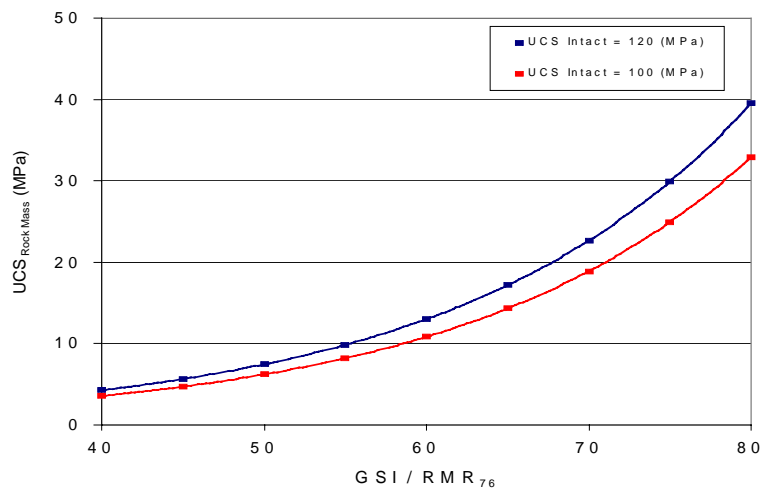
**Figure 4** Increase in  $UCS_{rock\ mass}$  with increasing GSI or RMR<sub>76</sub>

Although the derivation of a particular rock mass rating can be subjective, it is important to note that the relation between rock mass rating and rock mass strength is an exponential function, as illustrated in Figure 4. At high RMR<sub>76</sub> values, a minor variation in rating results in a significant variation in the equivalent rock mass strength.

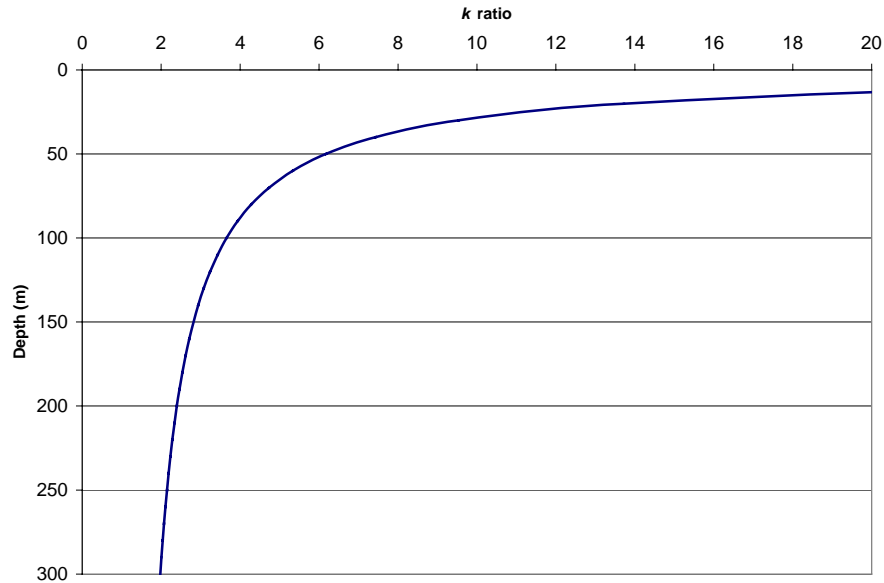
**Figure 5** Variation of *k* ratio with depth based upon Herget's (1988) equation

A depth of 300 m was used to determine the *k* ratio of 2.0. However, near the surface in the area of the crown pillar, Herget's equation predicts significantly higher *k* ratios, as illustrated in Figure 5. Assuming a depth of 50 m, the predicted *k* ratio is 6.2.

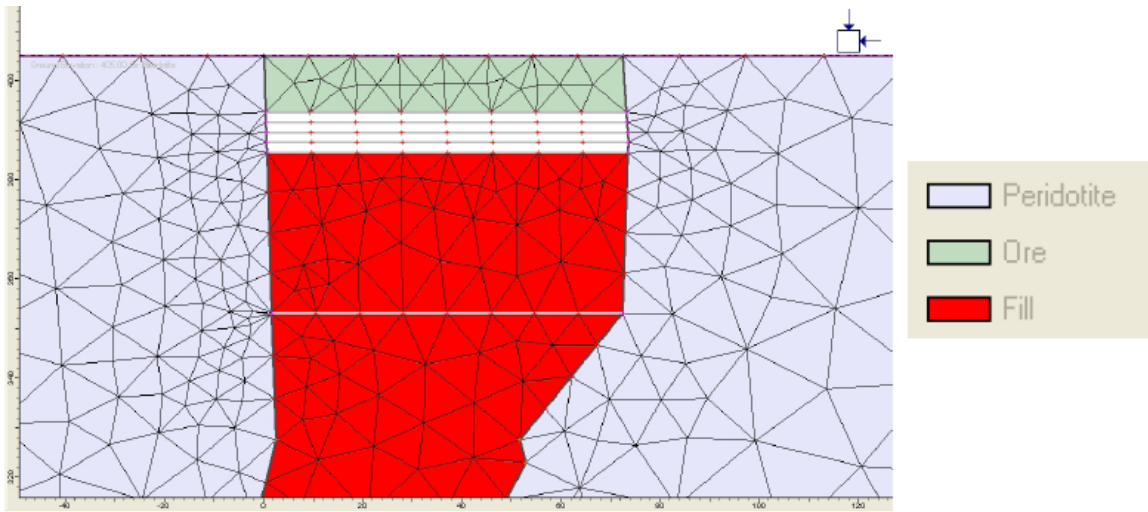
**Figure 6** *Phase<sup>2</sup> model geometry and finite element mesh (Golder, 2006c)*

Figure 6 illustrates the two-dimensional model geometry used to investigate crown pillar subsidence with the Phase<sup>2</sup> code. The two-dimensional, plane-strain analysis assumes that the crown pillar span is 68 m and infinitely long. The actual span is approximately 50 m, and its length is approximately 68 m.

The model is not considered to be realistic, as the finite element mesh used to discretize the crown pillar is extremely coarse and severely limits the accuracy of the modeling results. Only one or two three-noded triangle elements have been specified across the thickness of the crown pillar. The default value suggested within the Phase<sup>2</sup> program to ensure accurate modeling results is 10 elements (RocScience, 2005a).

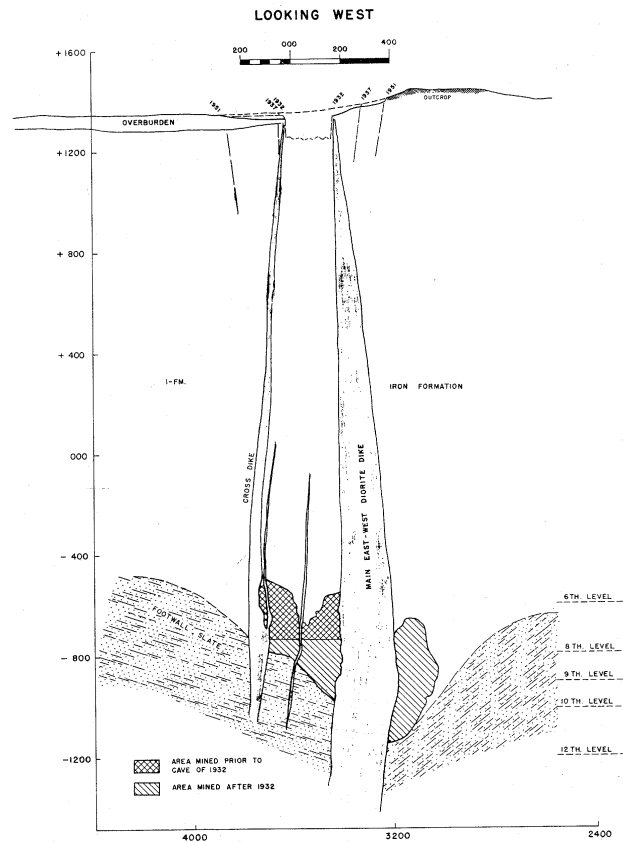
**Figure 7** Schematic of surface subsidence observed at the Athens Mine (Boyum, 1961)

Discrete sub-vertical faults have been identified as the cause of significant subsidence that was observed at the Athens Mine, in the Michigan Upper Peninsula, which is approximately 20 miles from the Kennecott Eagle project (Boyum, 1961). Vertical propagation of rock mass failure was controlled by sub-vertical fault planes, as illustrated in Figure 7.

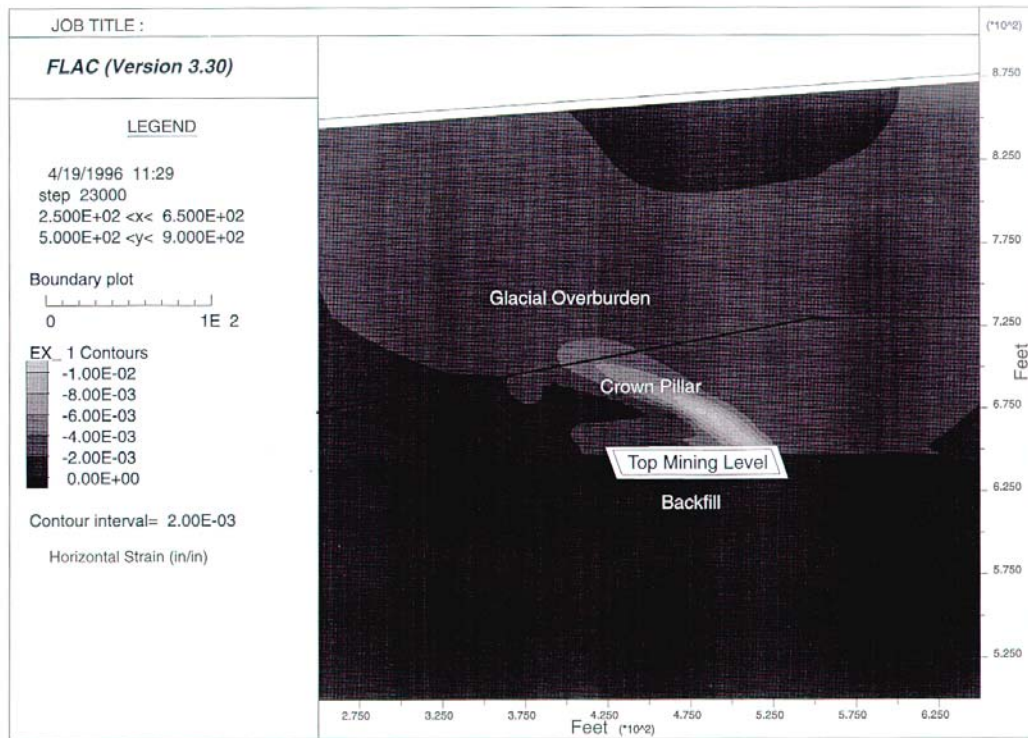
**Figure 8** Location of excessive rock mass strain within Crandon crown pillar (Hardy et al., 1999)

Hardy et al. (1999) adopted this approach for assessment of the proposed Crandon deposit in Wisconsin, which is located below environmentally sensitive wetlands. Mining induced strain surrounding the proposed crown pillar was analyzed using a non-linear modeling code to determine areas that exceeded the suggested strain limit. Figure 8 illustrates the area within the proposed Crandon crown pillar that exceeded a strain limit of -0.005 (-5.00e-03).

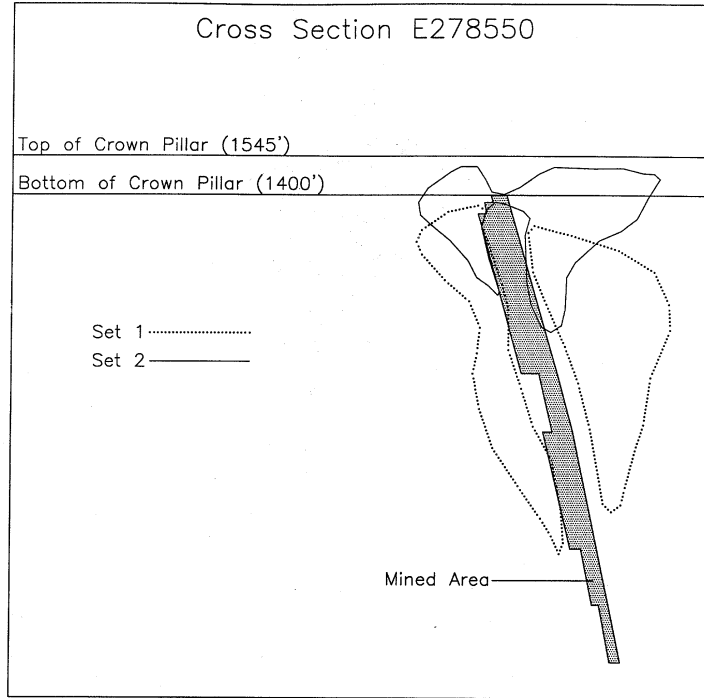
**Figure 9** Contours of factor of safety = 1 for predominant joint sets (width of orebody = 100 ft) (Hardy et al., 1999)

Further analyses were conducted to determine specific areas where shear dilation along the predominant joint sets would occur, as illustrated in Figure 9. Detailed distinct element models then were analyzed to relate the changes in joint aperture to a change in hydraulic conductivity. This level of analysis was considered industry-best practice for evaluation of crown pillar subsidence and hydrologic stability in 1999.
